Product Application Presentation

TCI 3300-50 H.D. (-37°C)

Process Identifier: All-season RED global long life engine coolant/antifreeze 50/50 heat transfer fluid

UNDERSTANDING THE COLOUR CHANGE IN LONG LIFE COOLANTS

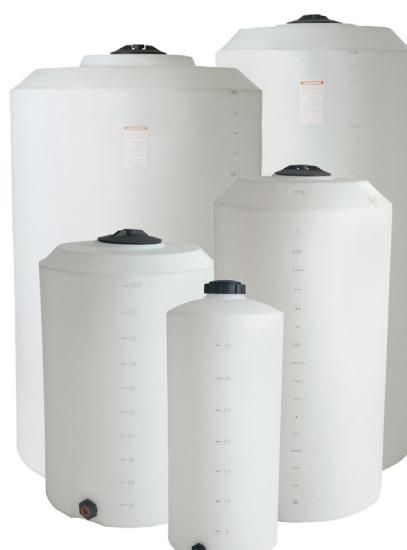
110 VAC or 12 VDC demand pump
Bulk dispensing system @ 5gpm

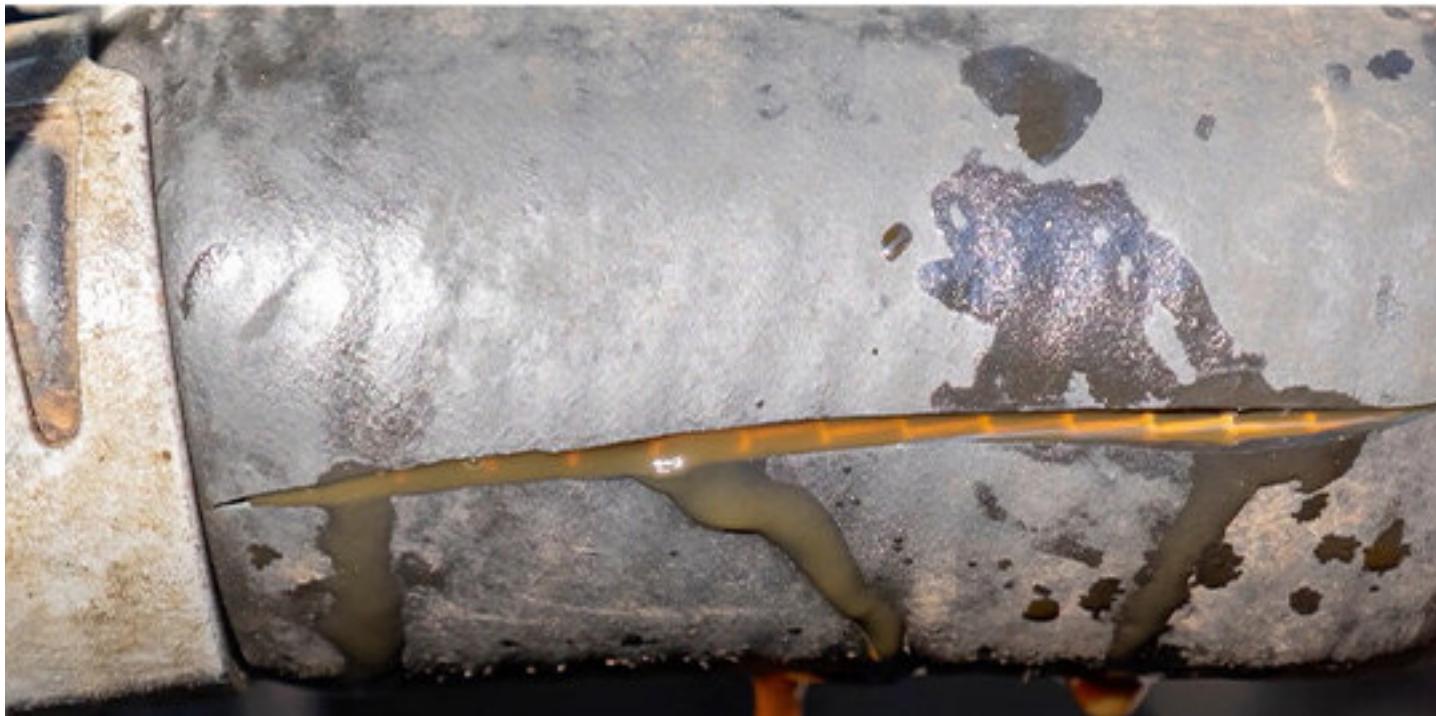
Typically when electrolysis occurs in engine coolant, there are hose failures. The long life coolant goes from red/pink colour to green/yellow and eventually black.

The most common failure mode on a standard, molded hose is electrochemical degradation, or ECD. ECD is caused by an electrical charge being carried through the coolant from component to component. It occurs because the hose, liquid coolant and the engine/radiator fittings form a galvanic cell or "battery." This chemical reaction causes micro-cracks in the hose tube, allowing the coolant to attack and weaken the hose reinforcement. Failures result from internal striations or cracks in the hose rubber, leading to pinhole leaks or a burst hose. Learning to test for electrolysis in the cooling system is an important skill. You can check for voltage in the cooling system by removing both cables from the battery and ensuring they do not contact each other or the vehicle, then touching the negative contact of a voltmeter to the battery ground or a known-good ground and suspend the positive lead in the coolant, making sure it is in contact with the coolant, but not touching any metal part of the radiator or cooling system. Both AC and DC voltages must be checked. Vehicles normally have DC voltages; however, a faulty engine block heater or faulty diode in the alternator can produce AC voltages.
